Phase 1 GeoEnvironmental

Desk Study

PROJECT ACORN

5th March 2013

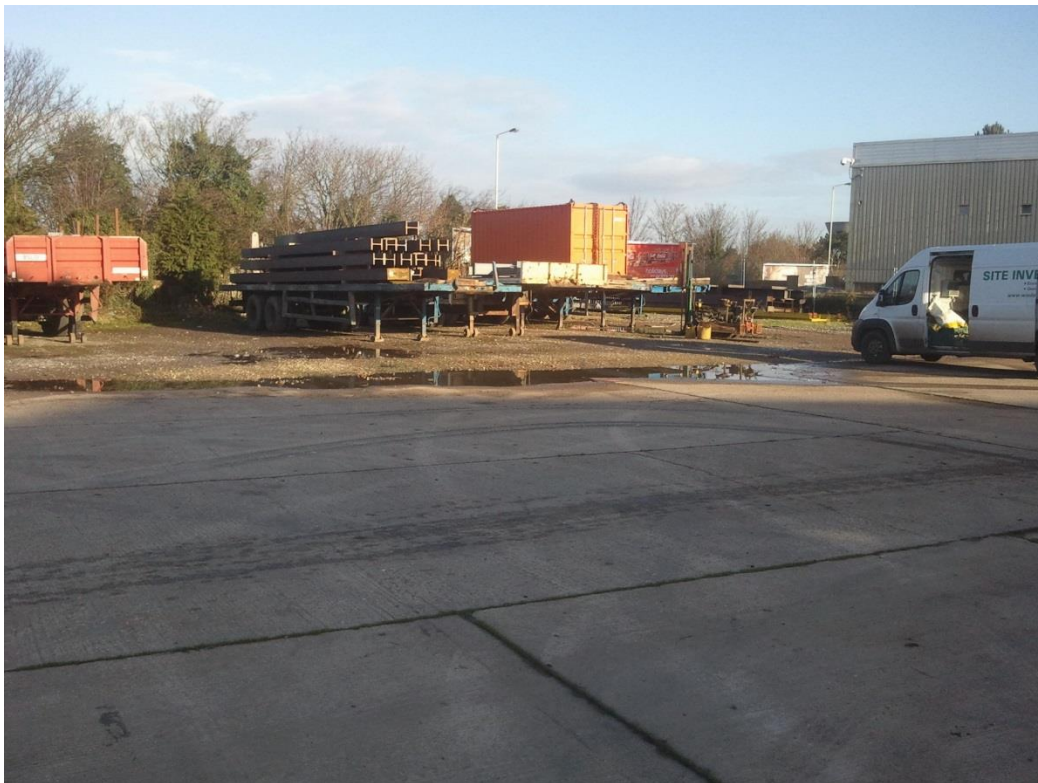
Ref.: BH01

Description: Borehole 01 location.
